Ecosystem Management Understanding

Kayrunnera Station

CASE STUDY

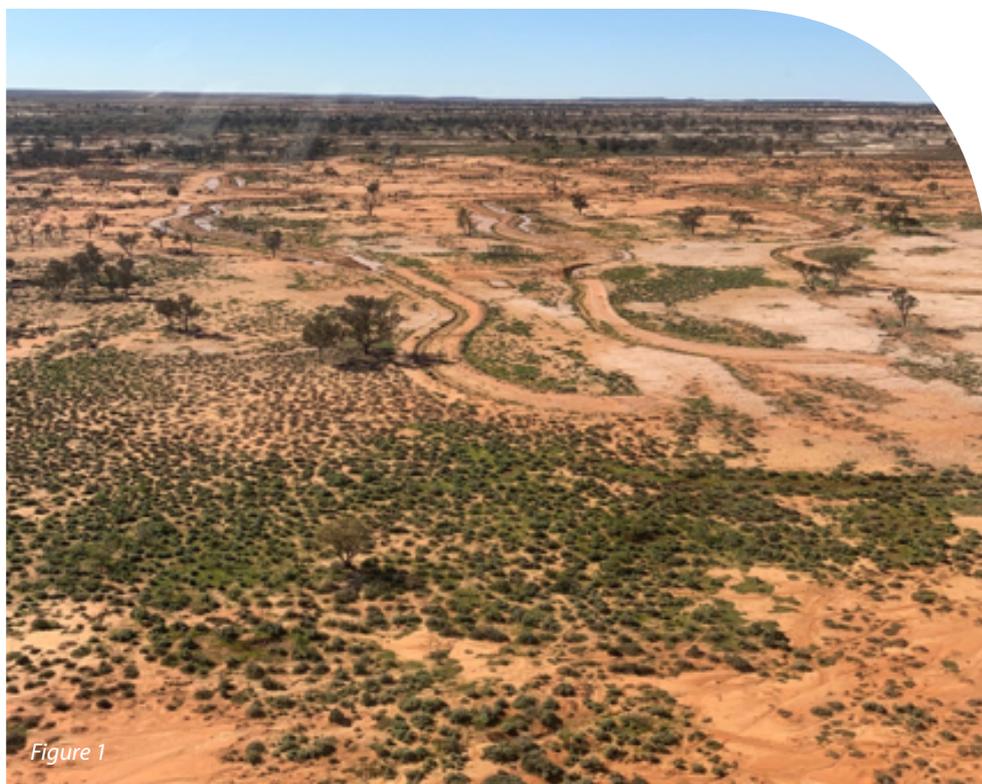
Figure 1

Figure 1: Waterponding techniques were initially used to reinstate a degraded floodplain.

There have been a number of strategies used at Kayrunnera over the years. Initially, waterponding was used to reinstate a floodplain. Waterponds were designed and constructed to pond water to a depth of 10 cm and the excess water would spill on a 150 m long level sill, see figure 1. This would mean that the water would spread over the floodplain, rather than flow down the rills and gullies in the centre.

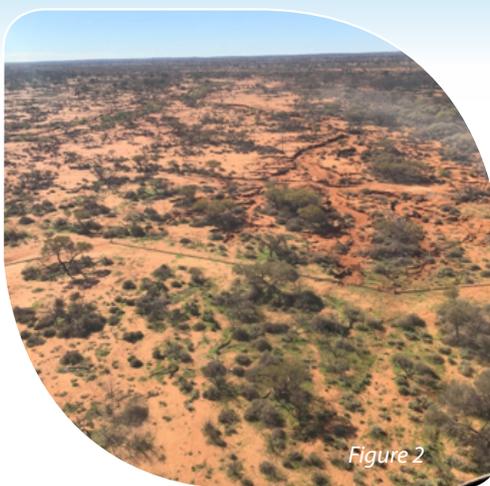
Figure 2

Figure 2: Mesh filters are being used to stop the further degradation of the floodplain. These filters block the movement of soil, reducing the formation of rills and gullies.

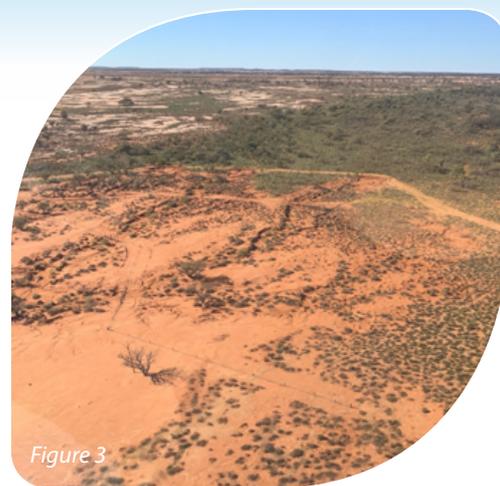
Figure 3

Figure 3: A series of mesh filters blocking the movement of soil through the catchment.

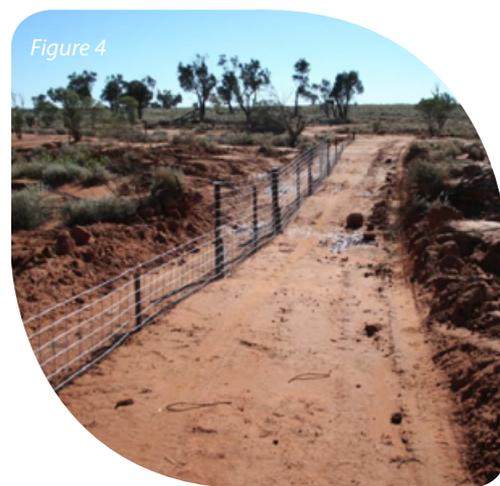
Figure 4

Figure 4: Mesh filters after construction.

More recently due to a concern about performing earth works on delicate country, mesh filters (see figure 4) have been implemented to address gully head erosion in the catchment area. The aim of these filters is to slow the movement of water by blocking debris but allowing water to flow through. Over time these filters will form banks of soil to prevent the loss of top soil from the property, as seen in figures 2 and 3. This will prevent the battered down gully heads further receding and taking valuable soil water out of the system.
