LLS and farmers working to rehabilitate Big Jacks Creek

North West Local Land Services (LLS) and landowner Roger Ottery have undertaken a project to rehabilitate a portion of Big Jacks Creek in the Upper Liverpool Plains. The project that started in 2019 has already shown a major improvement in the water quality. Big Jacks Creek is now much healthier flowing through Roger Ottery's property. The riverbanks were once mainly just bare ground. Now, trees and vegetation have grown where only dirt could be seen two years ago.

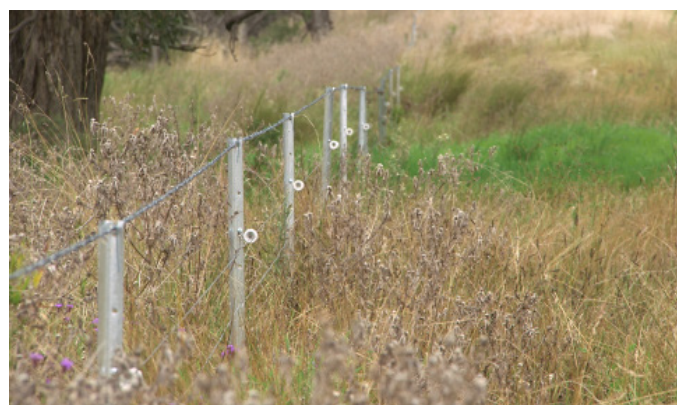
3.2km of electric fencing has been installed along the creek to manage cattle grazing.

Fencing the riverbanks to manage cattle grazing in the creek was a major component of the project. The cattle now only graze the riparian area 2 or 3 times a year for short periods and at high stock number densities. This allows for long recovery periods and for vegetation to regrow and groundcover maintained while still being utilised for production.

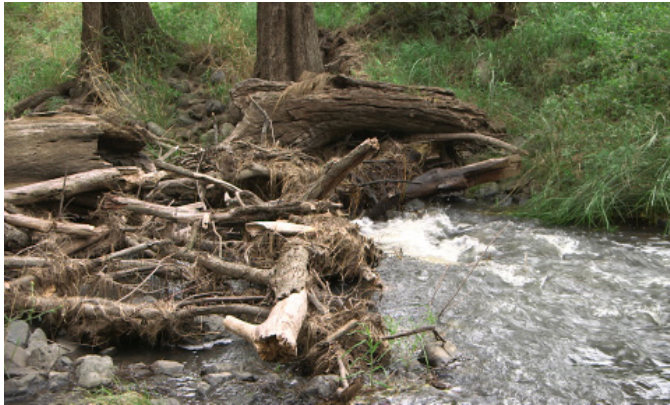
Fallen timber and vegetation create natural leaky weirs throughout the creek.

These natural leaky weirs create pools that hold water in the creek. This allows riparian vegetation to grow. All these elements help raise the water level of the creek and slow down the flow of the river. "If we can slow the water down, it's far less erosive and it gives that water a much better chance to get into the ground instead of draining away from the countryside," explains Tim Watts.

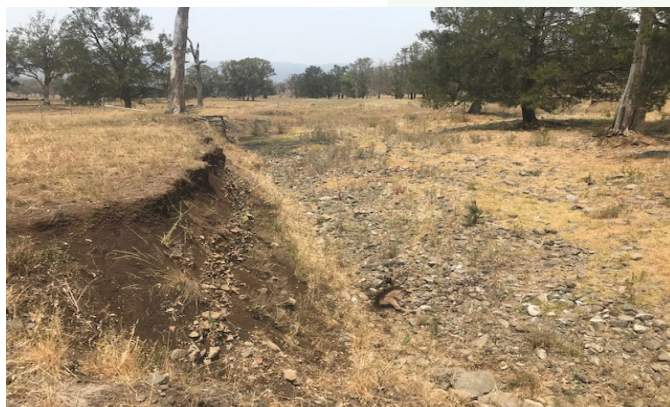
Big Jacks Creek prior to the rehabilitation project.

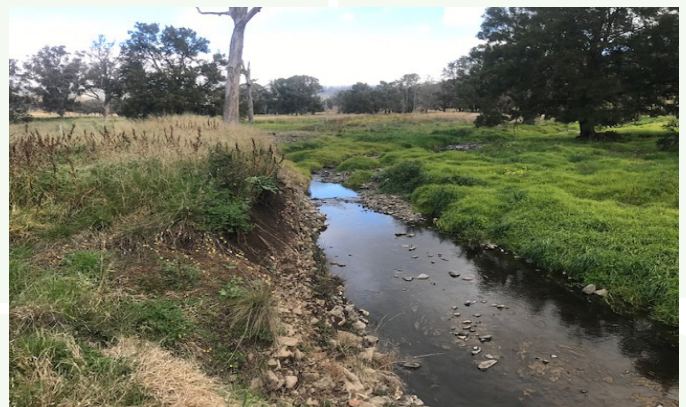
Big Jacks Creek one year into the rehabilitation project.
