Woodberry Swamp Hydrologic Study

WRL Technical Report 2016/03

By D S Rayner, W C Glamore and J E Ruprecht

Water Research Laboratory
University of New South Wales
School of Civil and Environmental Engineering

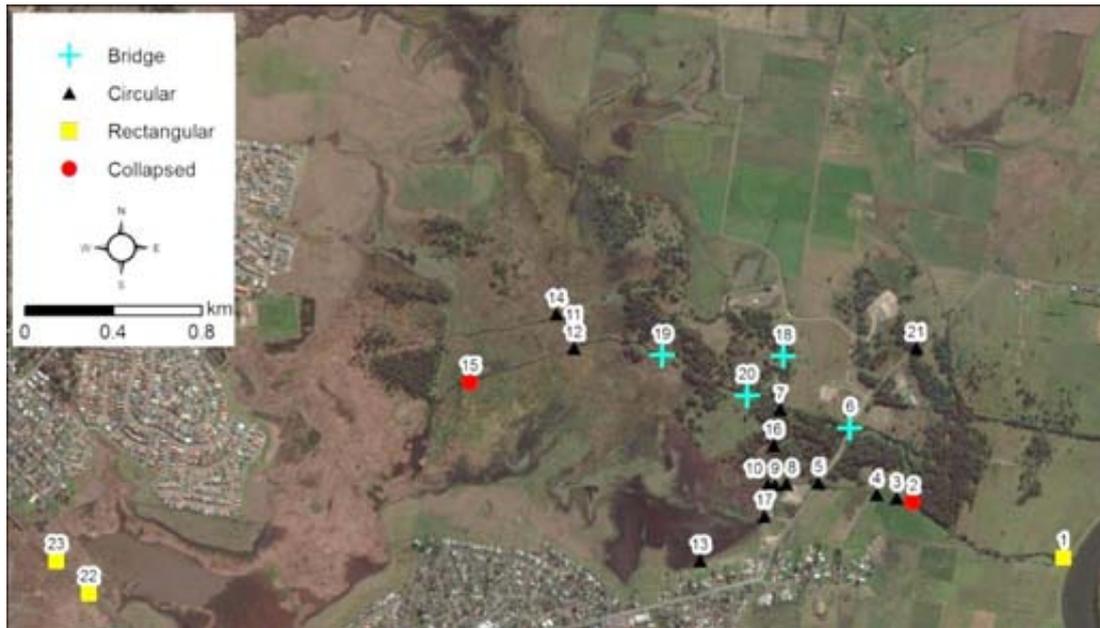
Figure 3.2: Key structure location and type (Background image: ESRI)

Channel geometry and hydraulic control structures (Figure 3.1, Figure 3.2 and Table 3.1) were used to represent the 1-D channel network. Where channel survey data was unavailable, geometry was interpolated or extrapolated from the nearest survey data.

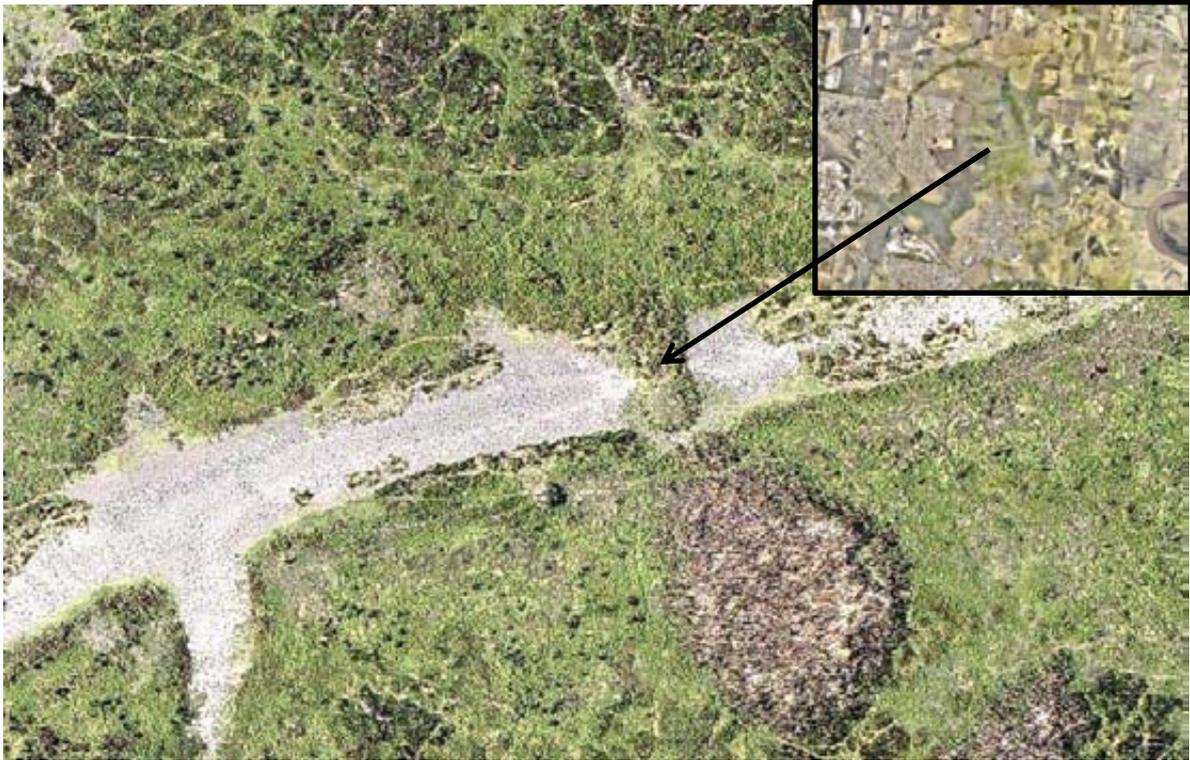
Figure 3.5: Collapsed culvert in the middle of the floodplain (Background image: Near Map)

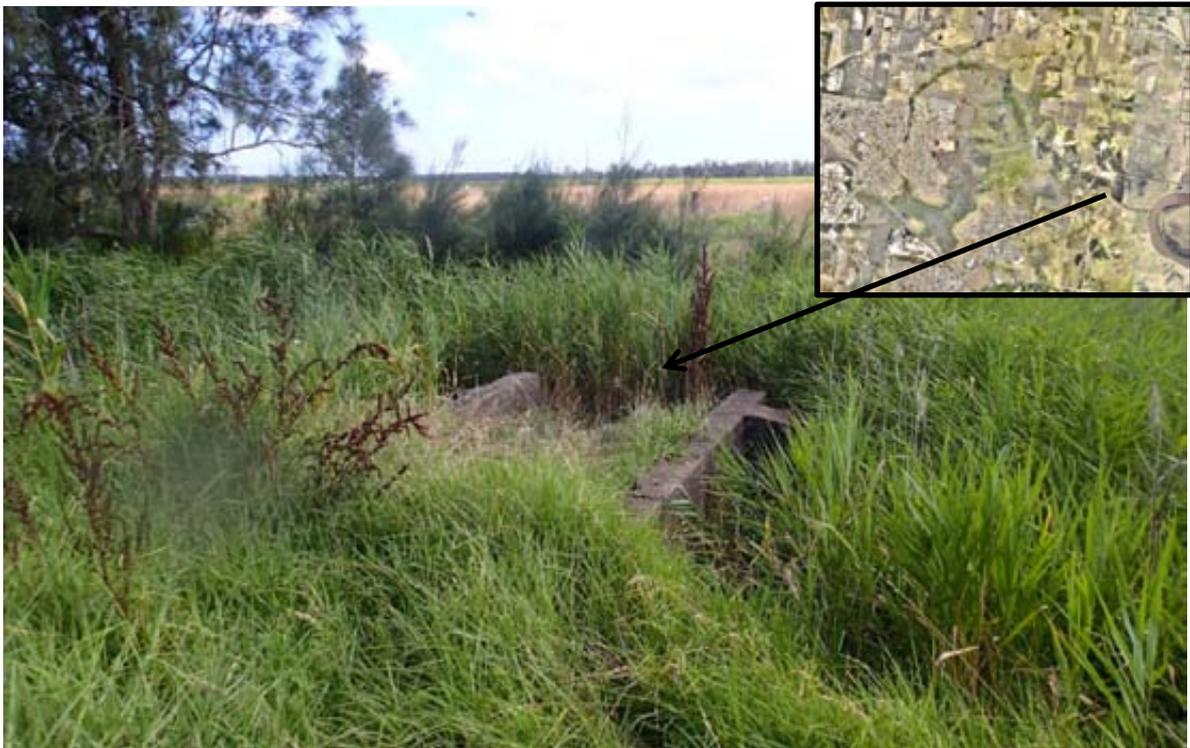
Figure 3.6: Collapsed culvert on side drainage channel, downstream of Woodberry Road

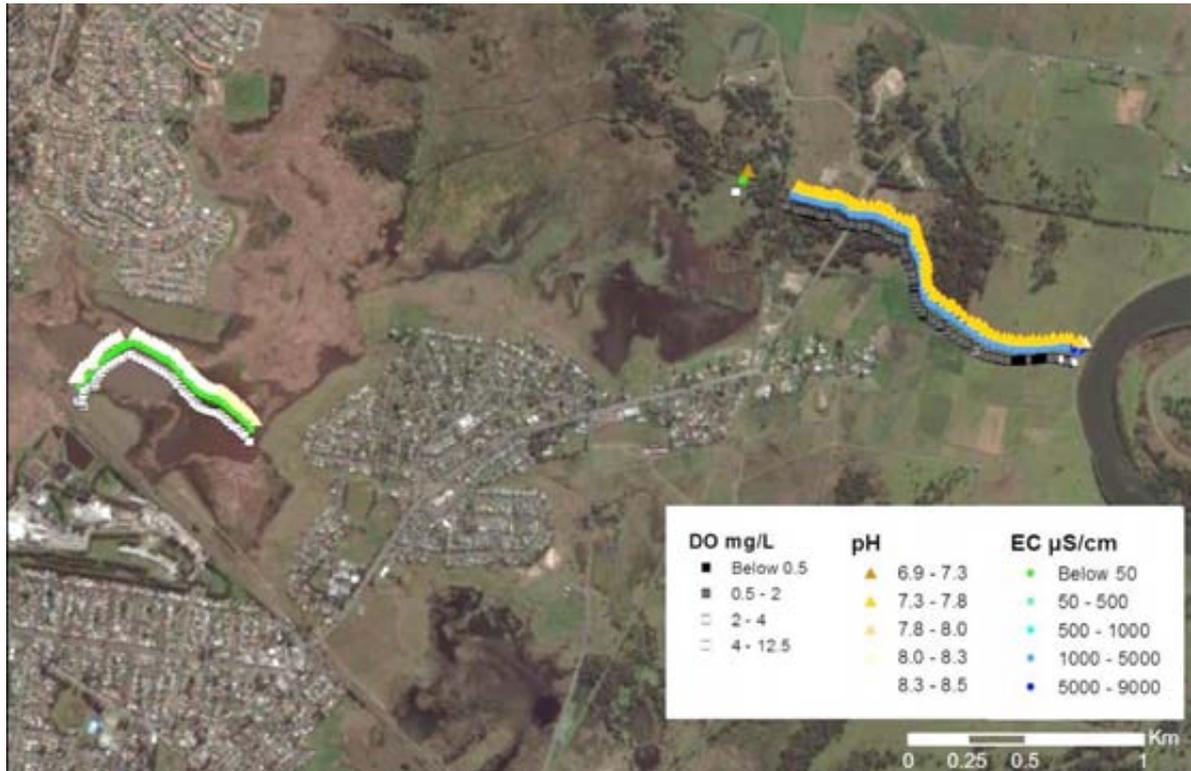
Figure 3.18: Water quality during field investigation (3rd Dec 2015) (Background image: ESRI)

Water quality during the field investigation for this study on 3rd December 2015 was measured using a YSI EXO2 multi-parameter water quality sonde (Figure 3.18). Acidity was observed to be near neutral pH. Electrical conductivity (i.e. salinity) was generally fresh, with higher conductivity measured near the floodgates. Dissolved oxygen (DO) was measured to be low at the downstream extent of Greenways Creek with DO concentrations below 2 mg/L, the concentration at which water becomes hypoxic to fish. DO concentrations in the open water backswamp areas were measured to be higher. Regular flushing of Greenways Creek would result in improved water quality including higher dissolved oxygen concentration, and connectively to the wider Hunter River estuary would benefit fisheries.

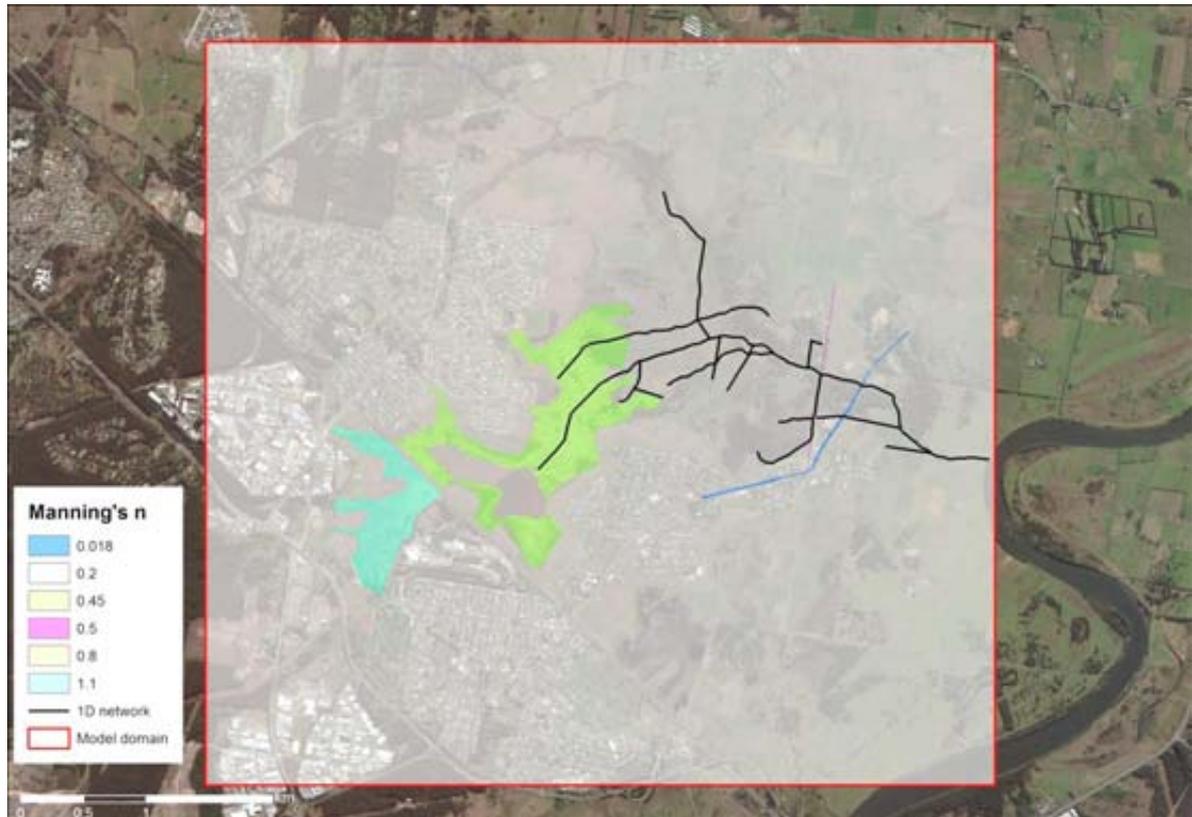
Figure 5.2: MIKE model roughness and 1D network

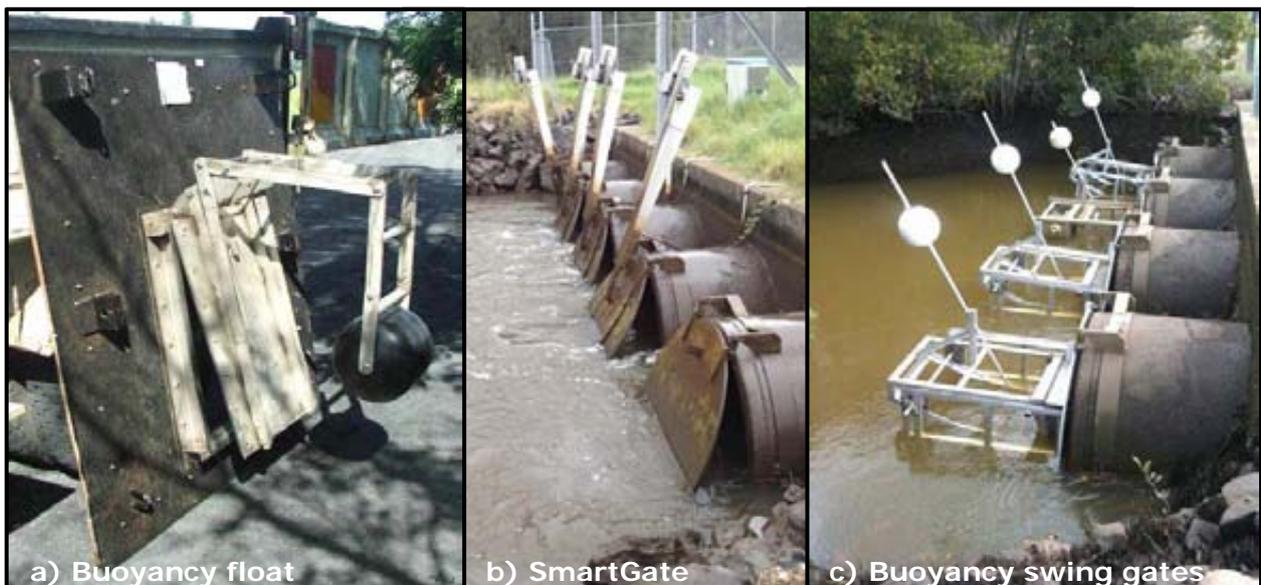
Figure 8.1: Different modified auto-tidal floodgate designs

A key concern with re-introducing tidal flushing is the potential impact on existing land use practices. The floodgates at Greenways Creek were initially constructed to limit tidal intrusion into the low-lying areas of Woodberry Swamp. Subsequently, any tidal flushing regime must consider existing land use practices. Flushing is achieved by modification of the steel floodgate with a hole cut in the middle. A hinged flap is installed to close the orifice and limit flushing at a specified elevation to protect upstream assets. A number of common modified floodgate designs are shown in Figure 8.1.

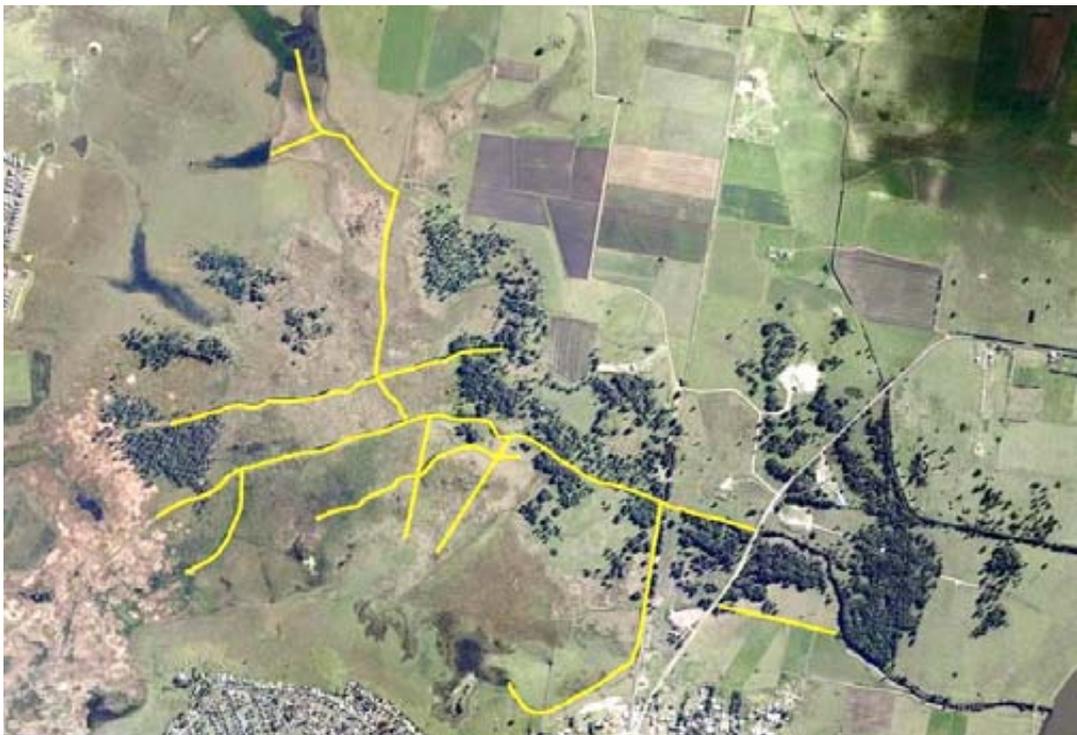
Figure 8.2: Identified drainage channels with significant in-drain vegetation

Based on an excavator cost of approximately \$3,500 per 500 m, mechanical cleaning of the drains presented in Figure 8.2 would cost approximately \$60,000. Note that excavation of sediment for channel deepening or widening would increase costs and require further assessment and approval. Weed treatment of the excavated sediments may also be required. A cost-benefit analysis of the resources required, considered against the benefits to affected landholders from increased drainage, is recommended prior to implementing this option.

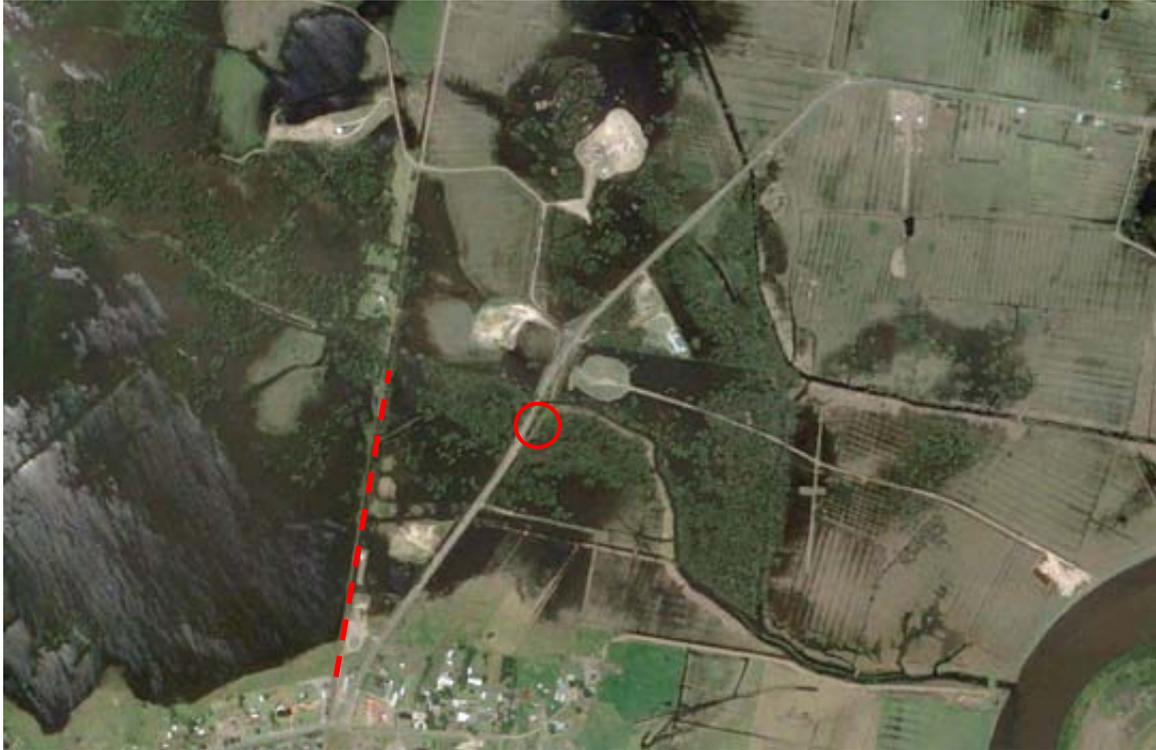
Figure 8.4: Removed section of pipeline, and modified Woodberry Road cross-section for numerical model scenario (Background image: Google Earth)

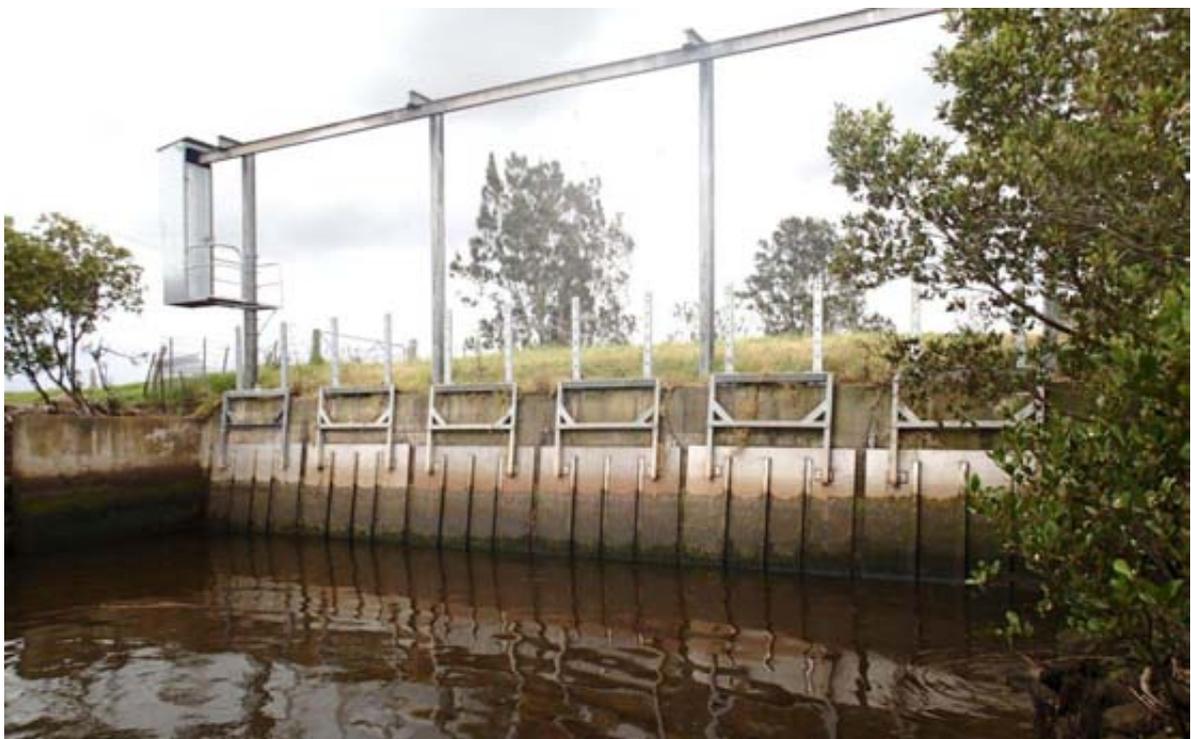
Figure D.2: P1 – Woodberry floodgates downstream

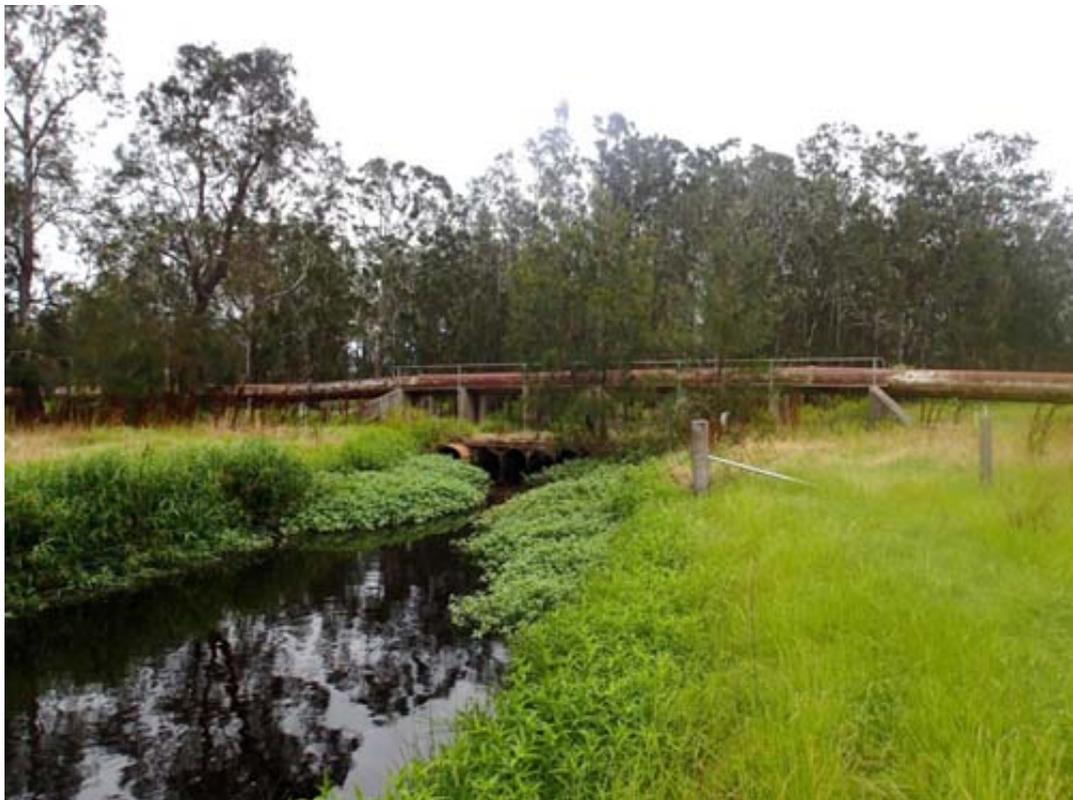
Figure D.6: P5 – HWC pipeline at Greenways Creek

The Hunter Water pipeline is difficult to represent numerically. The pipeline is elevated above an embankment with concrete blocks at varying heights resulting in a gap of approximately 0.3 m beneath the pipeline. An access roadway runs parallel to the pipeline and is also elevated above the floodplain. The pipeline spans concrete causeways at a number of locations, with corresponding culverts beneath the access road to enable floodwaters to flow across the pipeline alignment. Hydraulically, the pipeline acts to hold high elevation water back, with some flows discharging under sluice conditions beneath the pipeline. This was represented in the model by increasing model roughness along the pipeline alignment to replicate an increase of headloss. Conversely, roughness was reduced along Woodberry Road to represent reduced friction provided by the bitumen road surface.

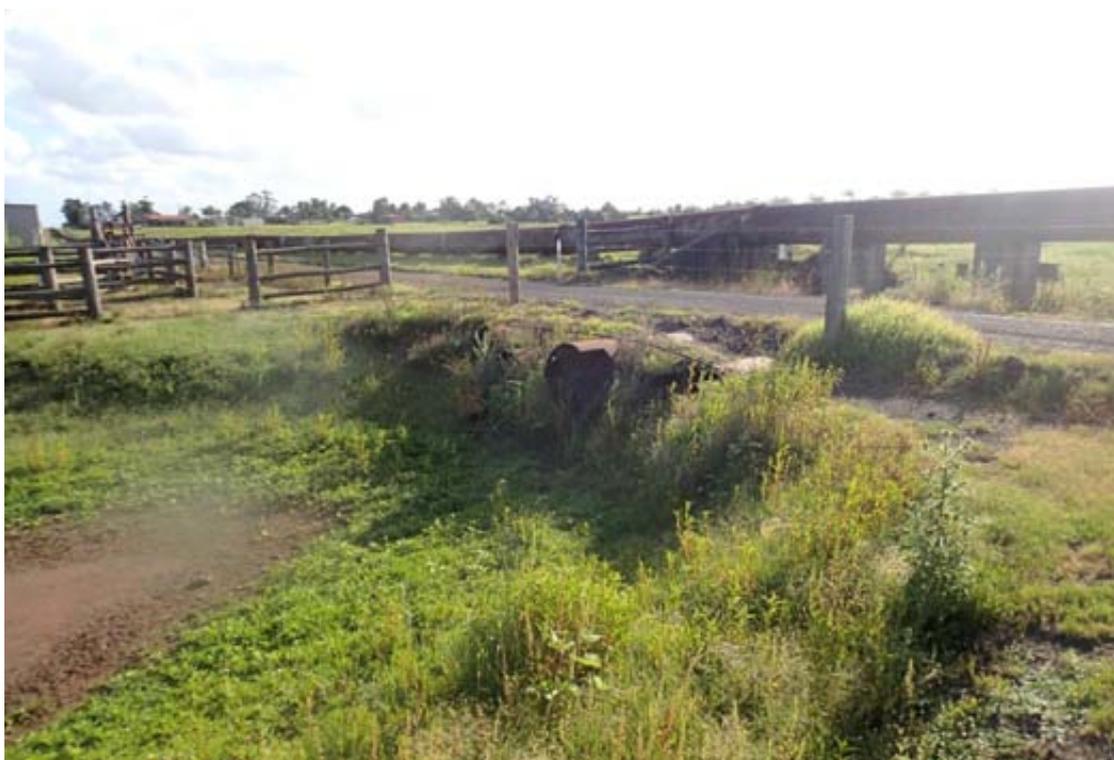
Figure D.8: P7 – Culverts under HWC pipeline access road

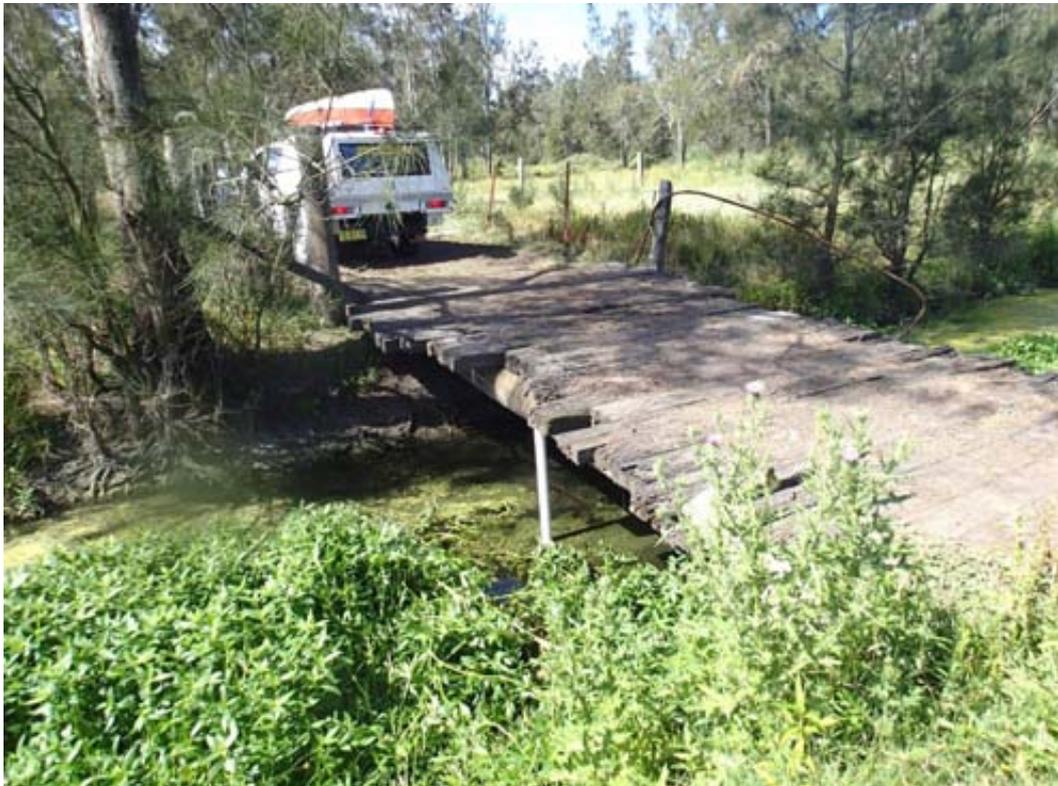
Figure D.12: P11 – Water level logger installation on wooden bridge at Greenways Creek
