Post-fire small-scale erosion control

Fact Sheet 1 – Types of Erosion and their Impacts

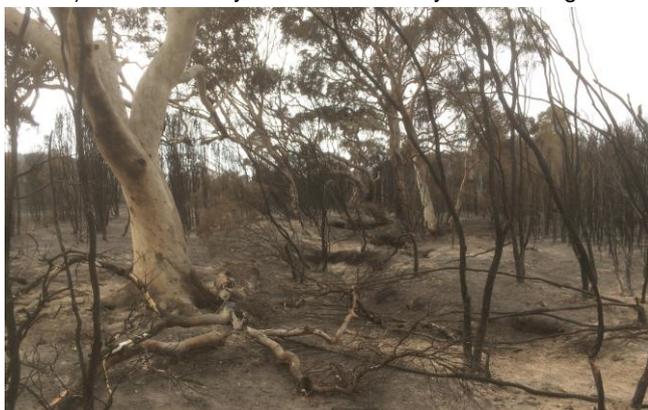
Figure 1: Burnt areas are more erosion prone due to lost tree canopy and groundcover (living vegetation and dry matter). Soil chemistry and structure may have changed.

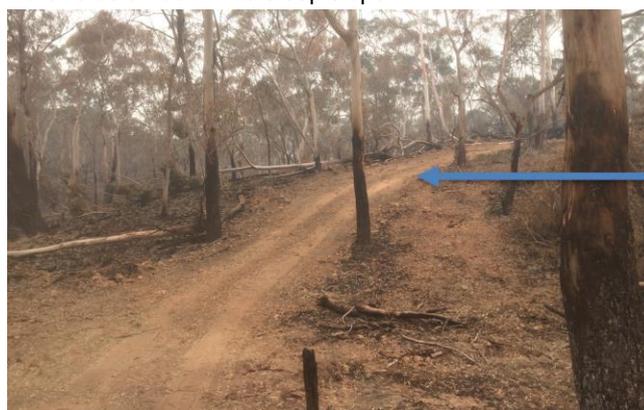
Figure 2: The blue arrow in the photo below indicates a suitable place for a roll over bank to be installed to reduce water erosion down the steep slope.

Roll over banks constructed across slopes can carry run-off but must spill into thick groundcover to avoid erosion occurring off the road.

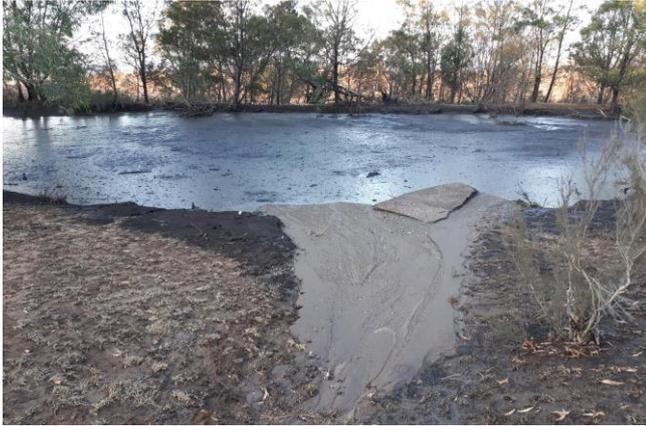
Figure 3: Floating ash washed into this dam has lowered the water quality, making it unsuitable for livestock to drink.

Organic matter, ash and debris can wash over unburnt paddocks into farm dams at some distance away from the fireground.

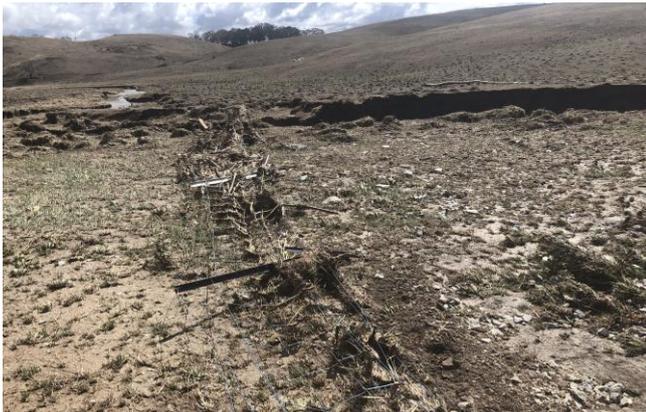
Figure 4: Increased run-off in this fireground has trapped debris in a hinge joint fence, now needing to be replaced.

Higher rates of runoff can damage fencing by trapping debris. There are modified fencing designs available to use in flood-prone areas, for example drop-down fencing and using plain wire rather than hinge joint (see *Stock and Waterways* link below for examples).

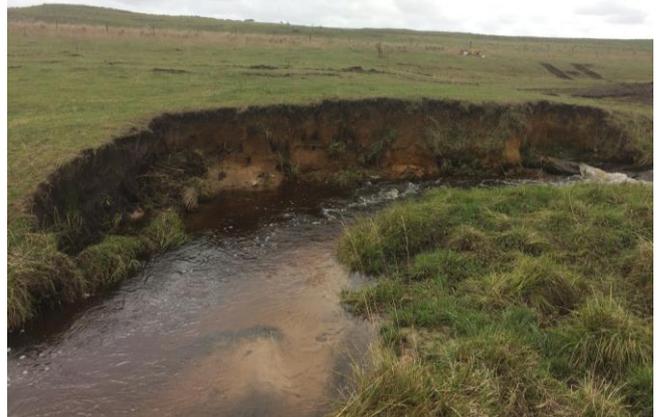
Figure 5: Low groundcover higher in the landscape leading to powerful waterflow has scoured the base of this creek bank on a tight bend. This can be difficult to control, and approvals may be required, so seek LLS advice.
