## Turning tin into gold at Wee Waa

## Snapshot

'Rosebrook', Wee Waa, NSW

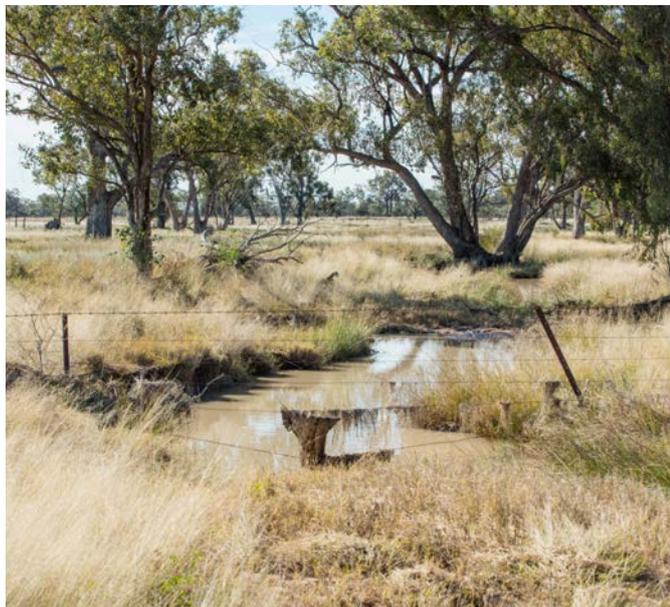
Womera Creek is more stable and healthy now that stock only access for a limited time instead of using as a permanent water source.

Work began in 2019 on both projects and the Dixons are thrilled with the results. The fenced riparian area along the creek has created groundcover along the banks, which has improved water quality. Installing additional watering

points (dams and troughs) has relieved pressure on the stream, and is no longer the main watering point, which creates a more managed grazing regime for the riparian zone.

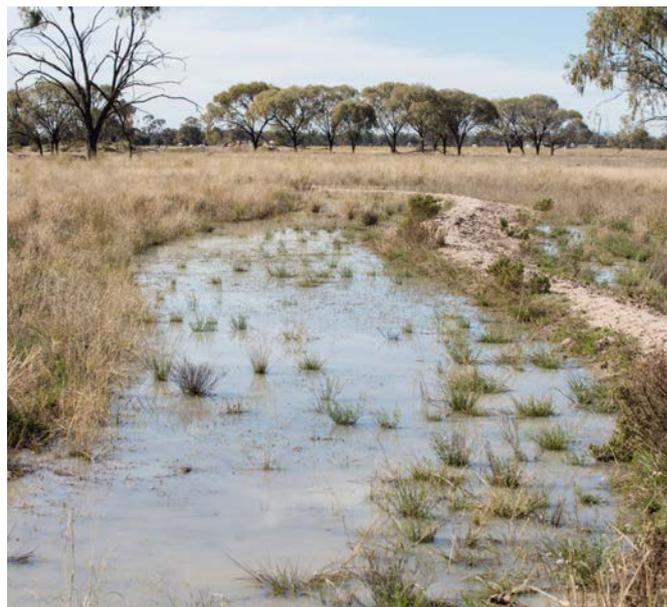
The water ponding banks were surveyed and marked out according to slope and soil type then constructed using a grader.

However, a remarkable turnaround has been achieved using a method known as ponding, which consists of a

series of small earthen banks to slow the movement of water across the landscape.

Installing the system in late 2019 required an initial survey, erection of the small bank configuration using a grader followed by planting a perennial tropical grass mix. Rain in early 2020 kicked the system into gear. Now with successive rain events, the bambatsi panic and other tropical perennial grasses are going well: helping the natives recover and choking out undesirable weeds.

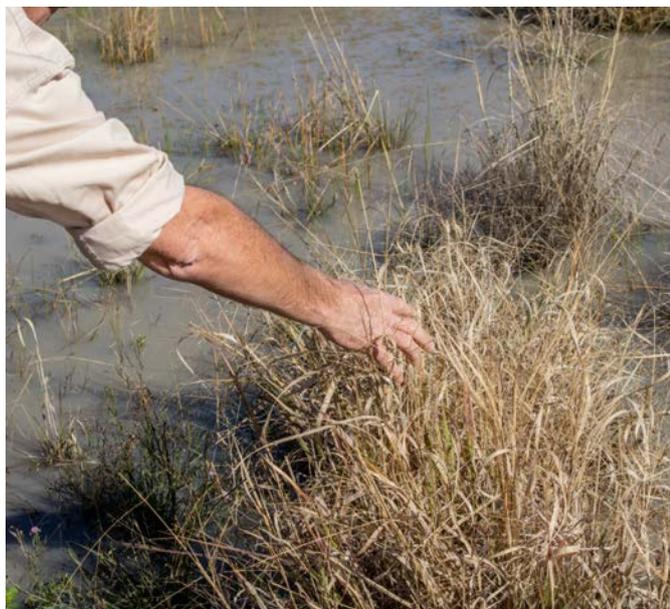
Increased groundcover, biomass and diversity of plants in the ponded areas will help carry the property through the next dry period.
